WL-TR-94-4112

**THE SURFACE PREPARATION OF
ALUMINUM ALLOYS USING THE
PHOSPHORIC ACID CONTAINMENT SYSTEM
FOR REPAIR**

SEPTEMBER 1994

INTERIM REPORT FOR PERIOD 01 JUNE 1992 – 31 DECEMBER 1993

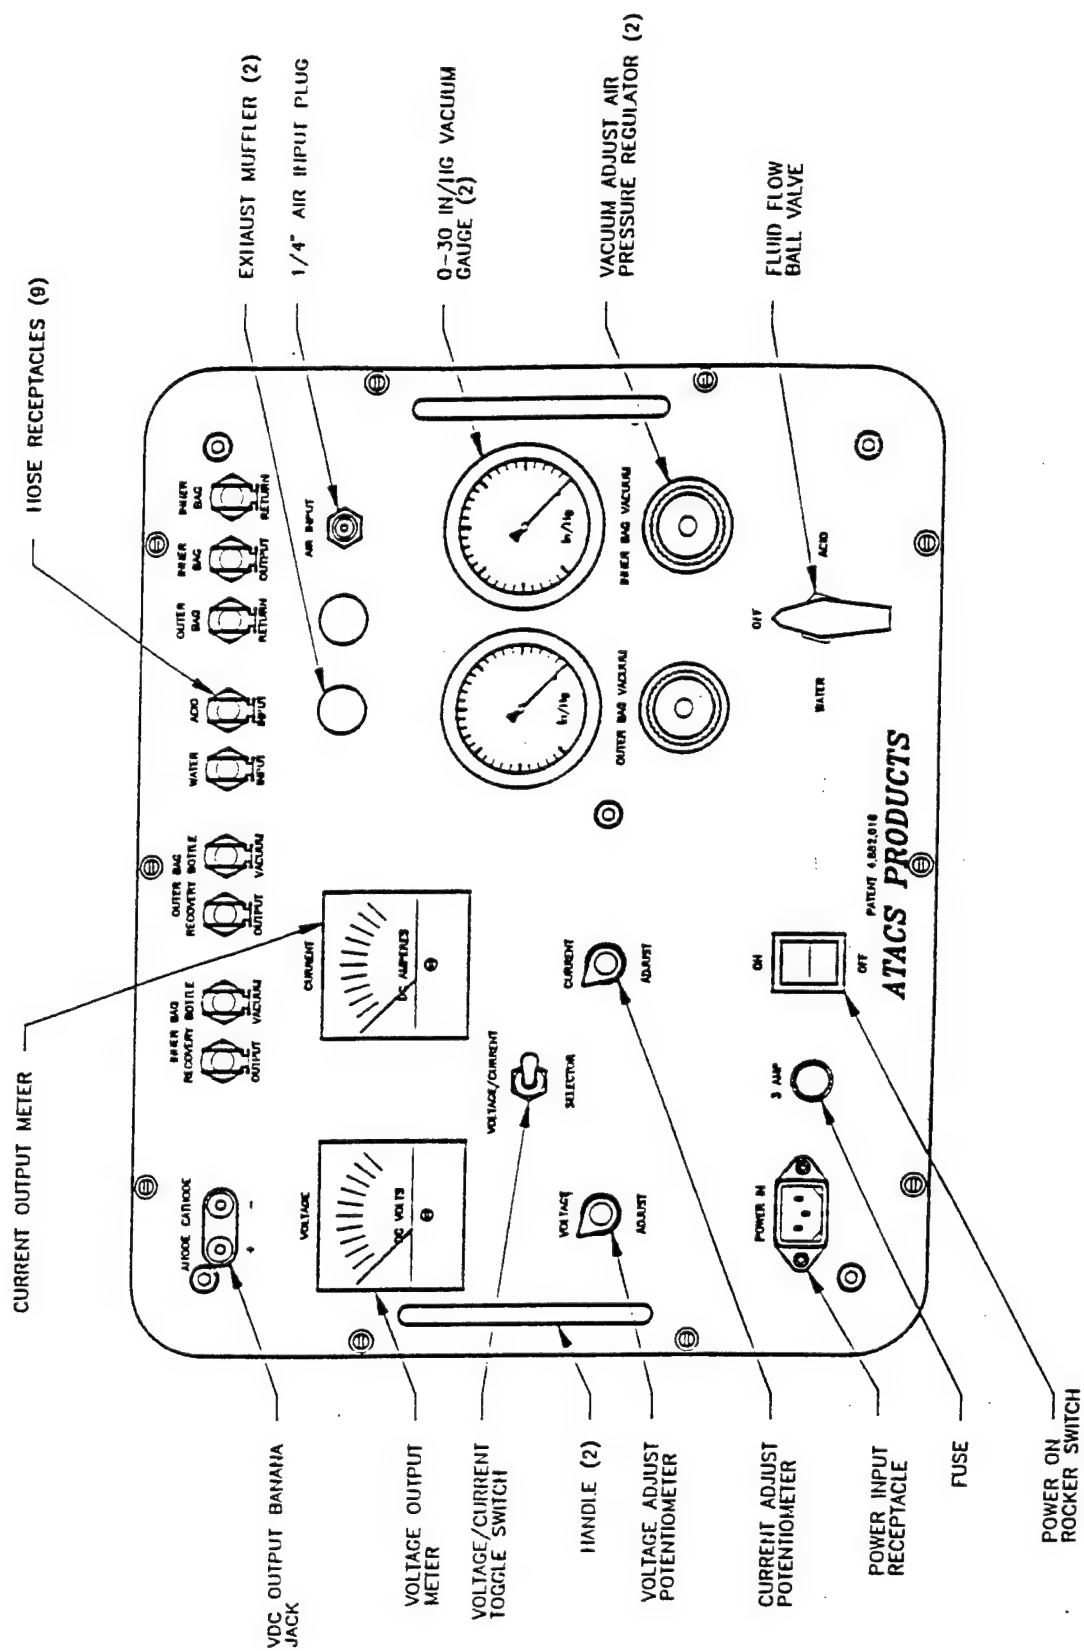
Figure 2. Phosphoric Acid Containment System (PACS) Control Panel

- A - Brown-Coded Inner Vacuum Bag Output Hose
- B - Green-Coded Inner Vacuum Bag Return Hose
- C - Yellow-Coded Outer Vacuum Bag Return Hose

Two types of tests were used for anodized aluminum surface evaluation: wedge tests and surface morphology characterization. Wedge tests were conducted to determine the integrity of the bond between the surface preparation and the adhesive. Surface morphology tests were conducted to compare the morphology of the standard phosphoric acid anodization (PAA) prepared surfaces with the morphology of the PACS prepared surfaces. Both oxide structure and thickness were documented. The sequence of activities used for this investigation is outlined in Figure 1. The PACS Model 0810 was utilized for all experimentation. This unit consists of a portable control panel which allows for the control of vacuum, voltage, and current. In addition, acid and water recovery bottles as well as connective tubing are utilized to contain the acid medium during anodization. Figure 2 illustrates the PACS Model 0810 control panel.

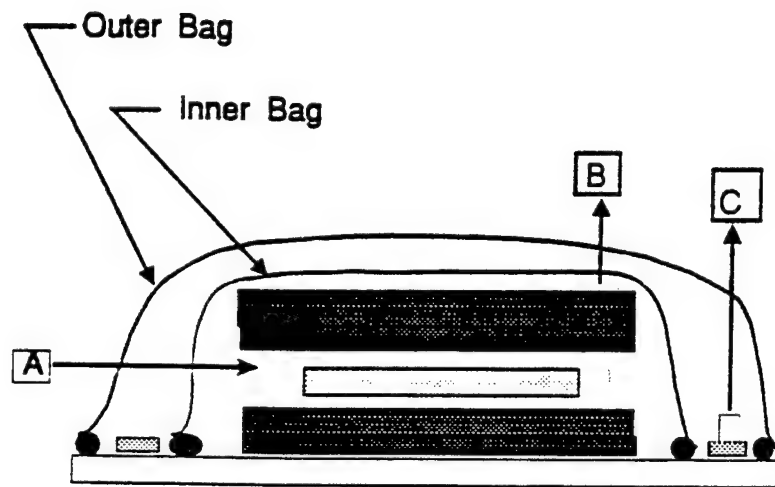
Figure 3. Stacking Sequence of Repair Area Lay-Up

- Aluminum Panel (Anode)
- 10 oz Airweave N10 Polyester Breather Cloth
- Stainless Steel Screen (Cathode)
- 1" Fiberglass Breather Cloth
- Vacuum Bag Sealant Tape

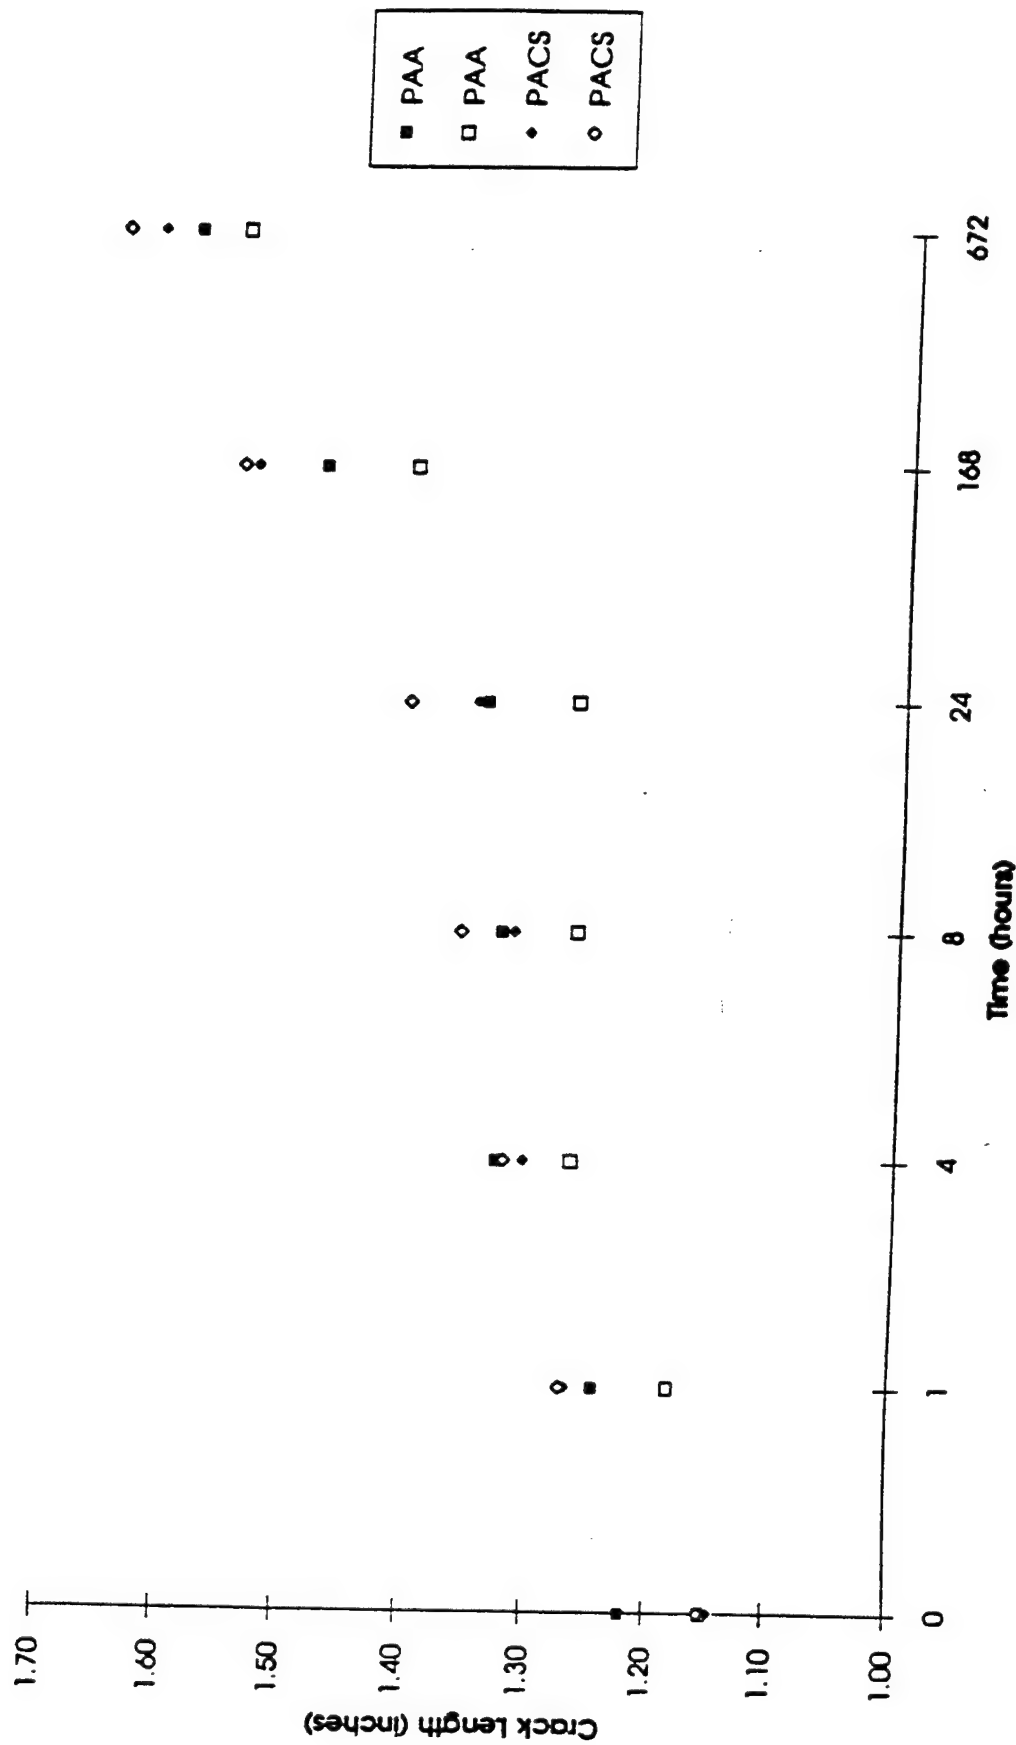
Figure 4. Average Crack Growth Curves Comparing PAA and PACS Anodized AI 2024-T3 Fabricated Using BR 127 Primer and AF 163-2 Adhesive

* All curves are an average of five specimens

Wedge test panels were prepared and tested as discussed in Section 2.2. All the panels were primed with BR 127 and bonded with either FM 73 or AF 163-2. The wedge test results for the 2024-T3 bare aluminum specimens that were anodized by either the PAA or PACS techniques are presented in Tables 2 and 3. Graphical representations of these results are illustrated in Figures 4 and 5. For both adhesives, the specimens that were anodized using the PACS technique showed crack growths similar to the baseline PAA prepared surfaces. Wedge test results for 7075-T6 bare aluminum specimens that were anodized by either the PAA or PACS techniques are presented in Tables 4 and 5. Graphical representations of these results are illustrated in Figures 6 and 7. For both adhesives, the specimens that were anodized using the PACS technique showed crack growths similar to the baseline PAA prepared surfaces.

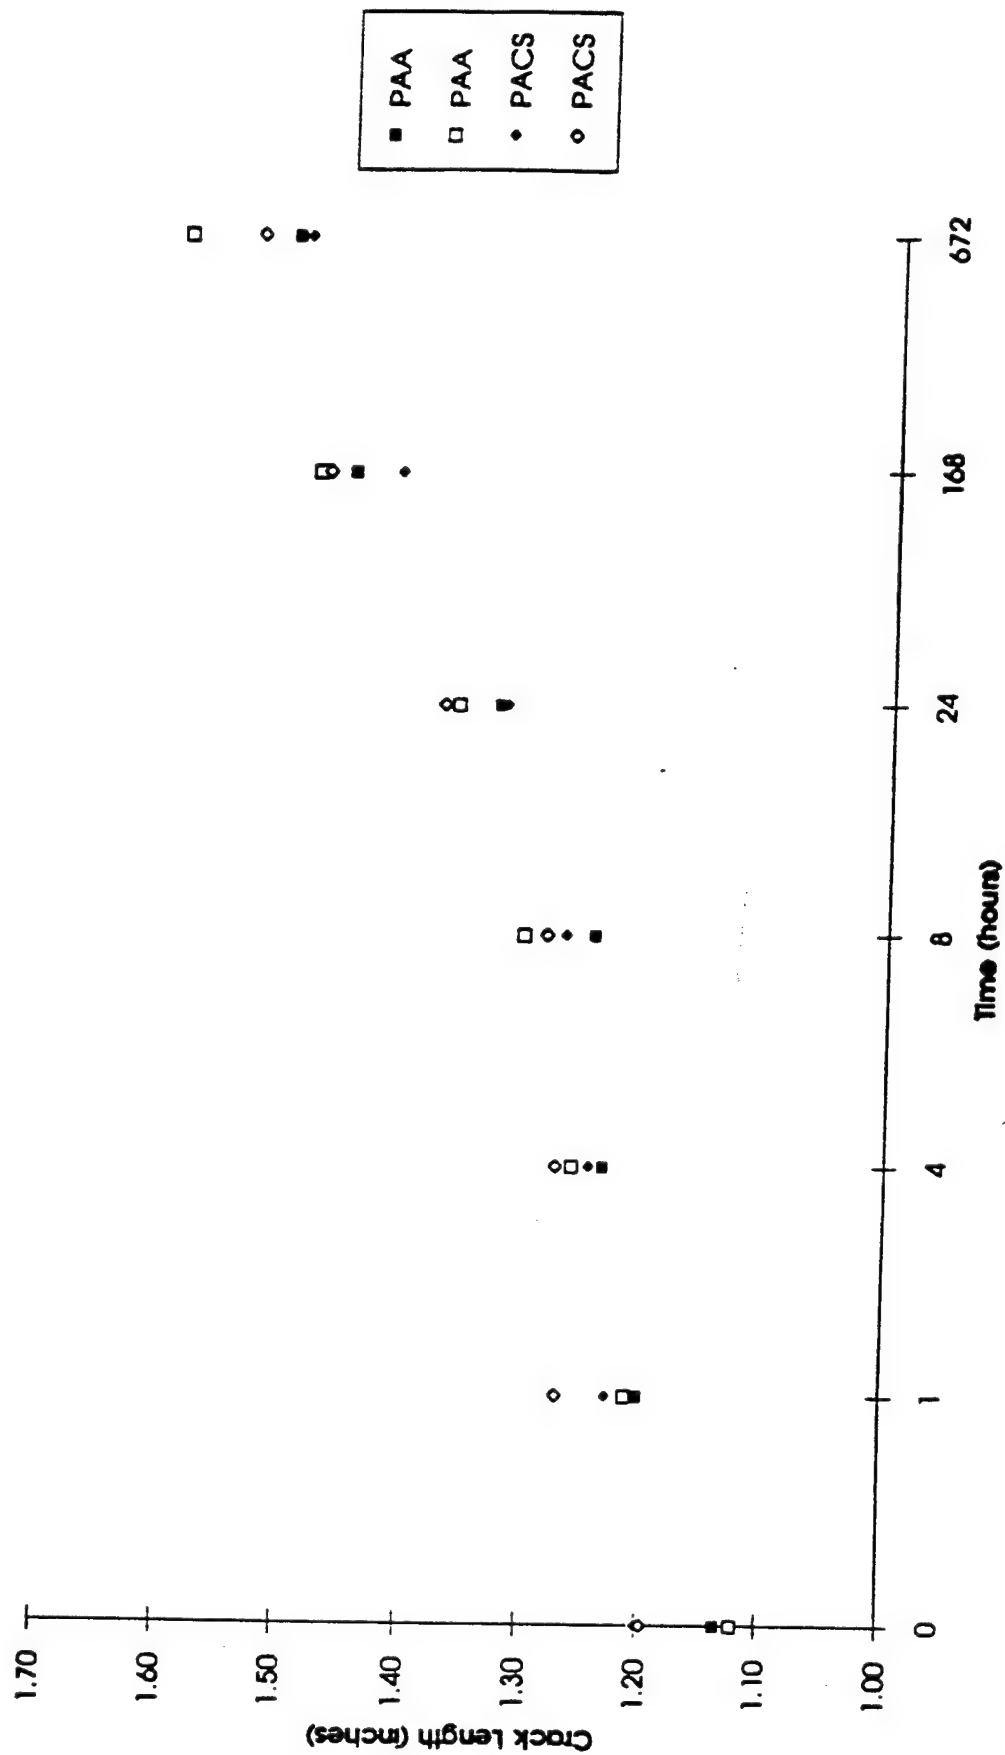
Figure 5. Average Crack Growth Curves Comparing PAA and PACS Anodized Al 2024-T3 Fabricated Using BR 127 Primer and FM 73 Adhesive.

*All curves are an average of five specimens

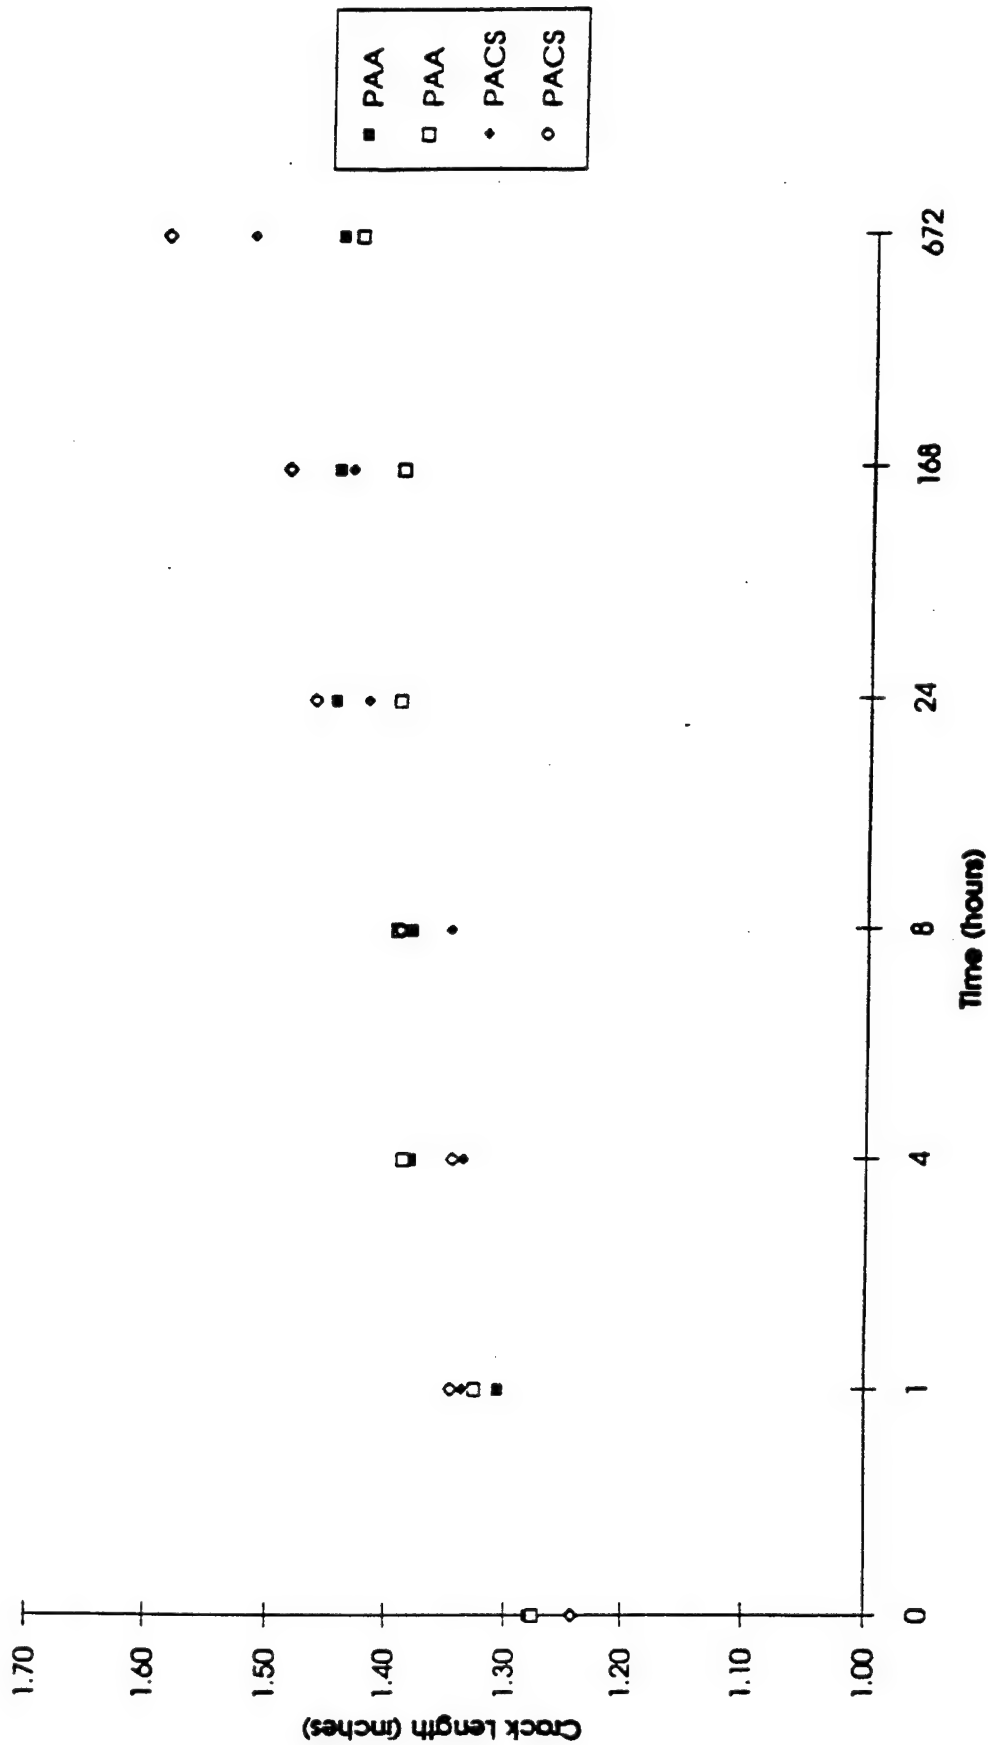
Figure 7. Average Crack Growth Curves Comparing PAA and PACS Anodized Al 7075-T6 Bare Fabricated Using BR 127 Primer and FM 73 Adhesive.

*All curves are an average of five specimens

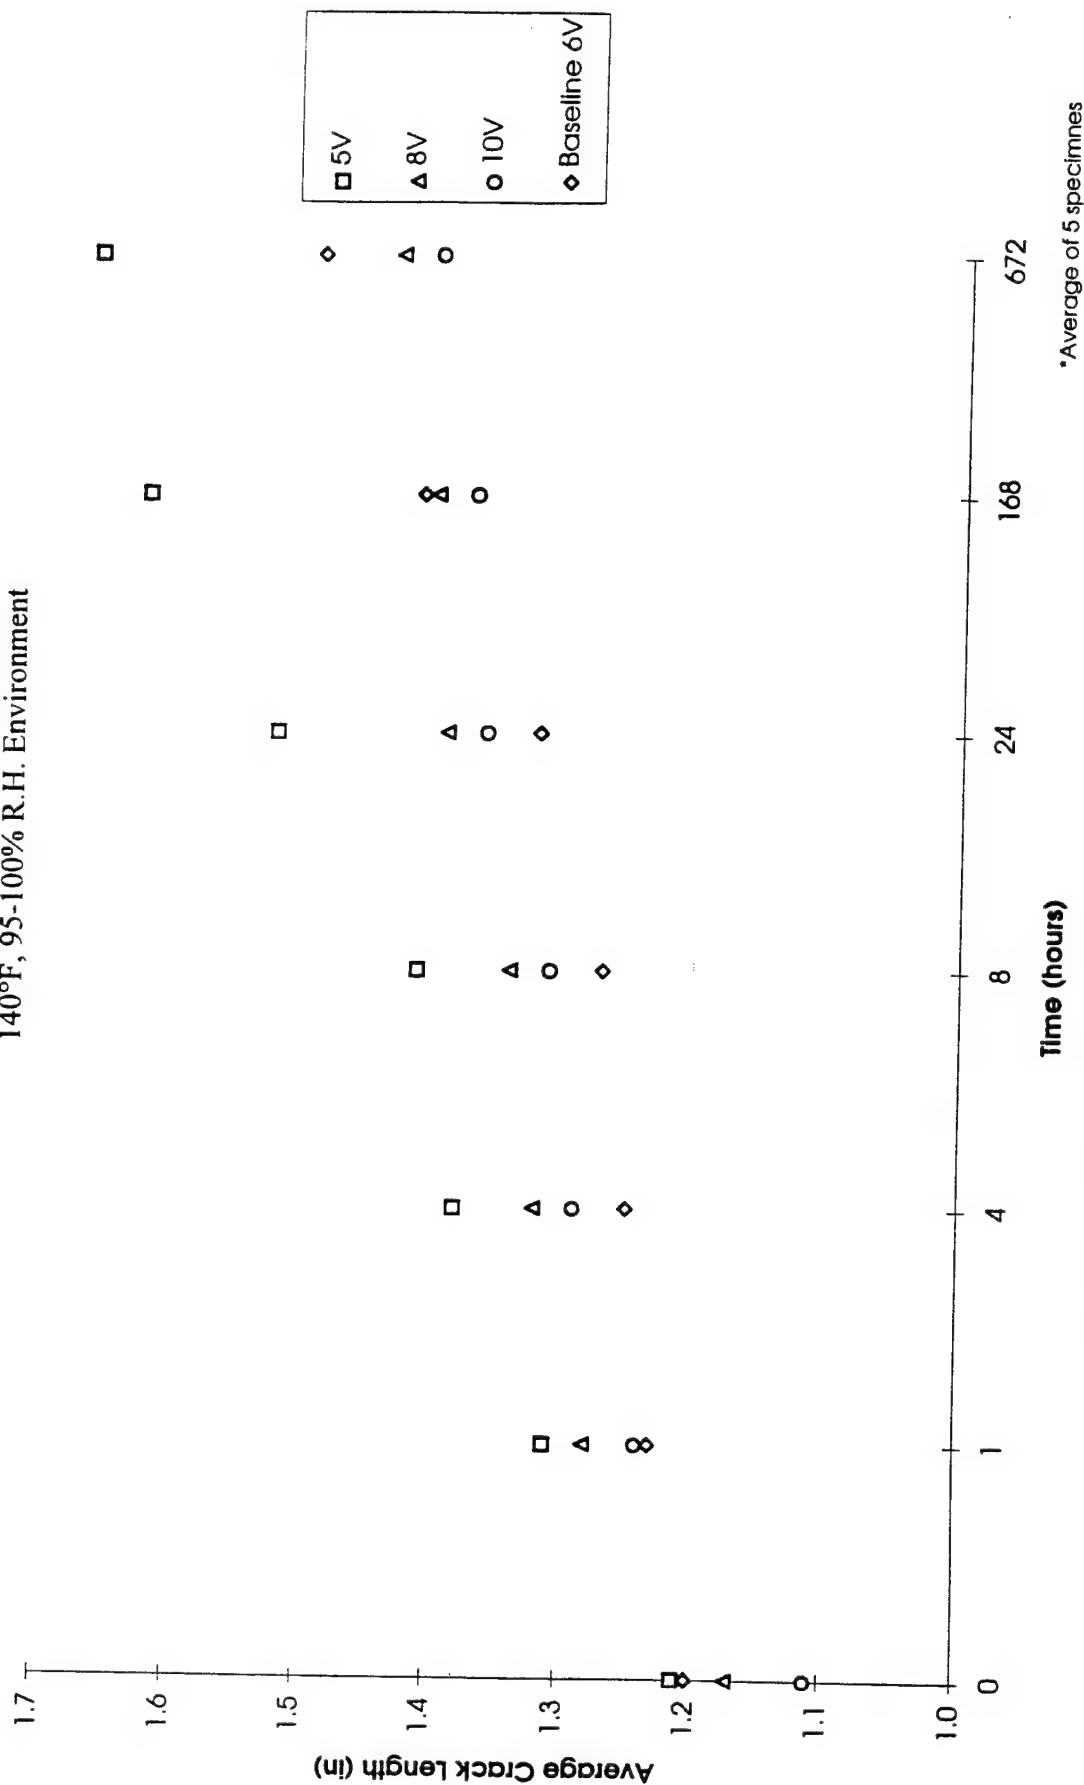
Figure 8. Effect of Voltage on Crack Growth Behavior

Cumulative Wedge Test Results
 Al 2024-T3 Bare/BR 127/FM 73
 140°F, 95-100% R.H. Environment

Several wedge test panels have been made with nonstandard voltage. Operational limits of the PACS unit ranged from a low of 5 to a high of 10 volts. Figure 8 presents wedge crack growth results for panels anodized at 5V, 8V, and 10V. Results indicate higher crack growth rate for those specimens anodized at 5V, which is out of the 6-10 VDC range recommended in the operating procedure.

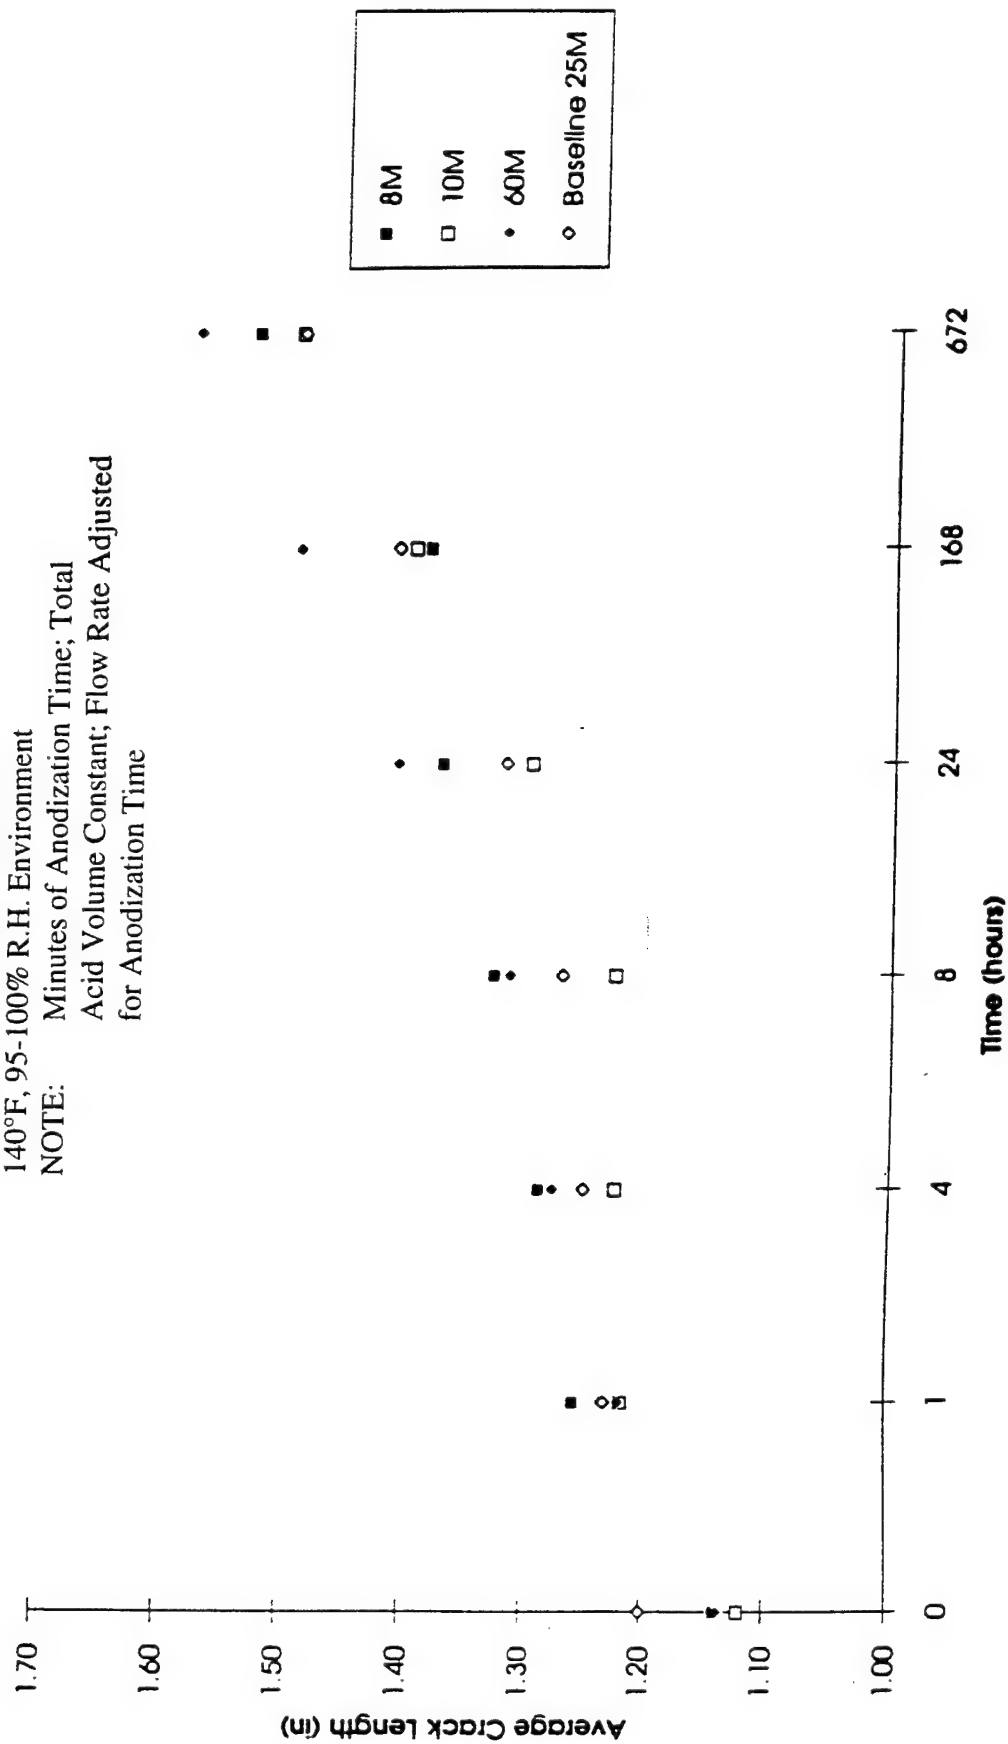
Figure 9. Effect of Anodization Time on Crack Growth Behavior of PACS Prepared Surfaces.

Minutes of Anodization Time; Total

Acid Volume Constant; Flow Rate Adjusted
for Anodization Time

*Average of 5 specimens

Several wedge test panels were made varying the anodization time. Anodization times ranging from 8 minutes to 60 minutes were utilized to anodize panel surfaces with the PACS unit. The acid flow rates for these panels were adjusted appropriately so that the 2-liter supply would last just long enough to complete the anodization. Thus higher flow rates were used for shorter anodization times and lower flow rates for longer times. Figure 9 presents wedge crack growth results for panels anodized for 8 min, 10 min, and 60 min. Figure 9 illustrates that although 25 minutes is recommended, an anodization time of 10 minutes would be sufficient to successfully anodize the surface. Also, extending the anodization time to 60 minutes does not significantly affect the surface quality.

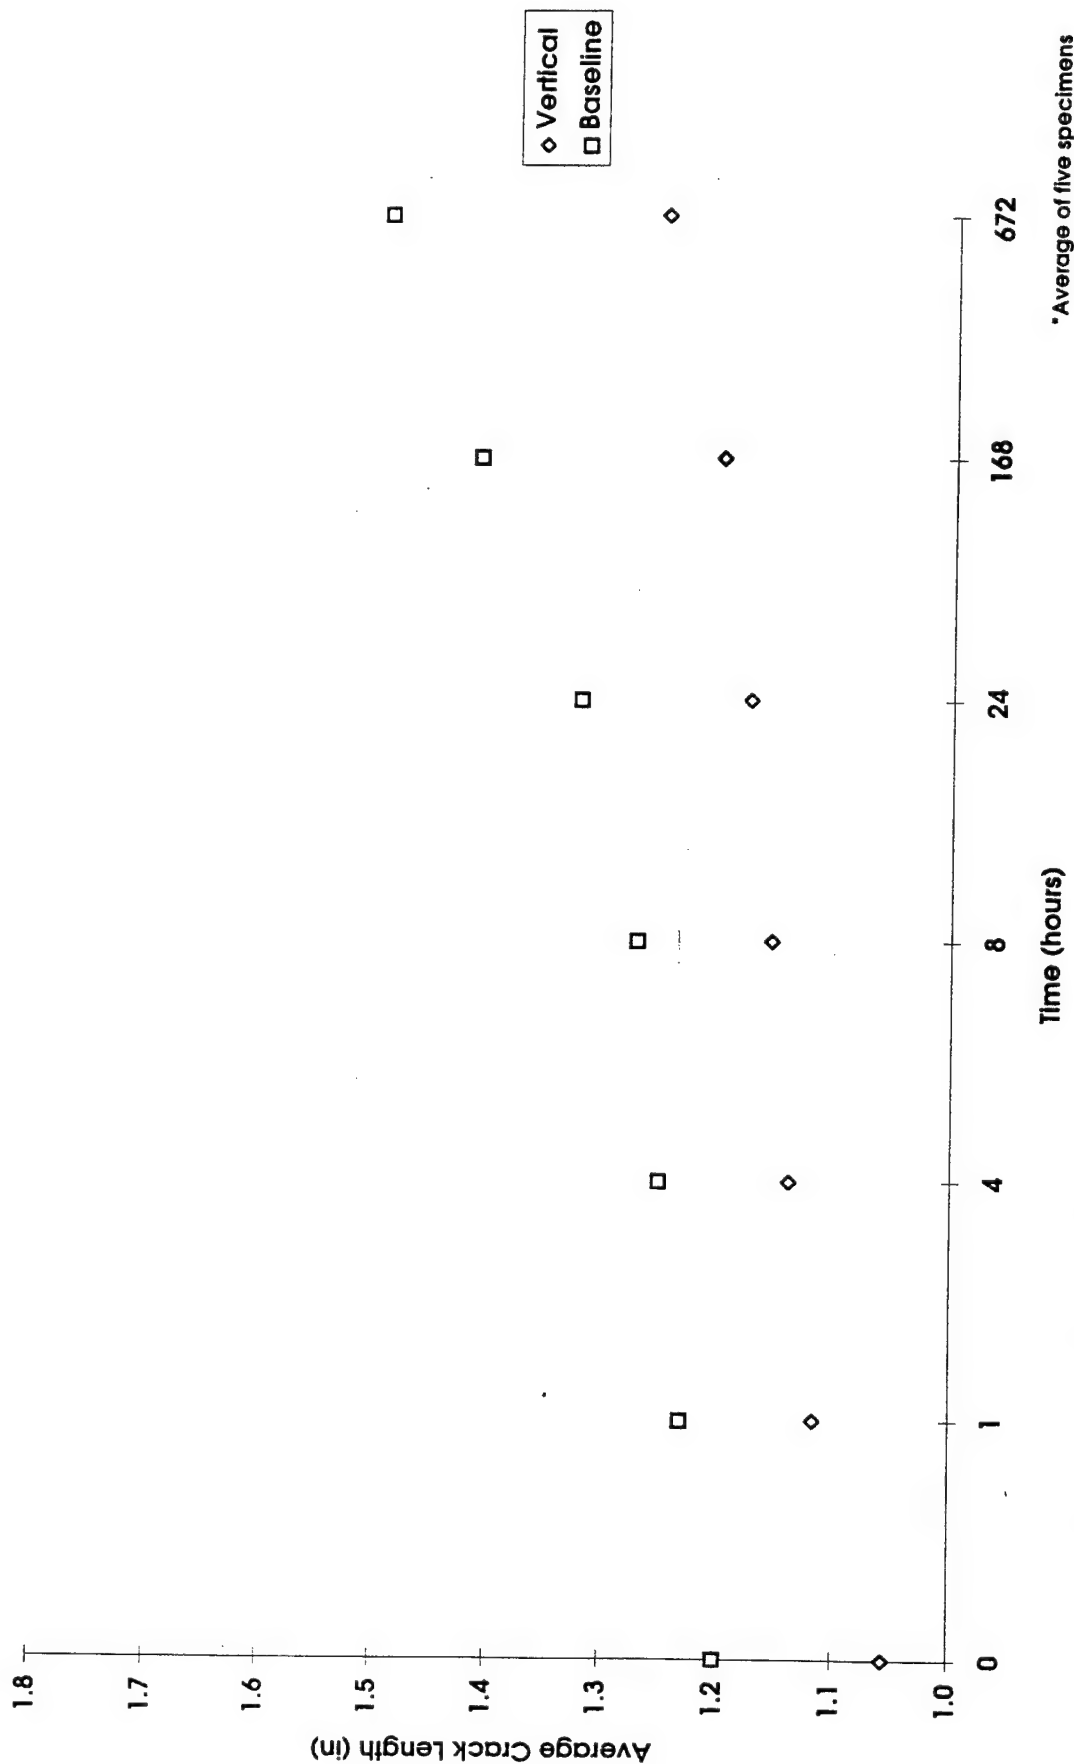
Figure 11. Effect of Panel Position on Crack Growth Behavior of PACS Prepared Surfaces

Cumulative Wedge Test Results AI 2024-T3 Bare/BR 127/FM 73

NOTE: Blackened symbols indicate adhesive failure, while open symbols indicate cohesive failure. Symbols that cannot be blackened indicate cohesive failure.

All baseline data was generated by performing a PACS anodization on a horizontal surface. For comparison purposes, aluminum panels were also anodized in both the vertical and inverted positions. It was observed that in order to achieve good anodization over the entire surface of a vertical panel, the flowrate must be reduced and the acid inlet must be at the bottom of the panel. On a 6" X 6" panel, for example, the flow rate had to be reduced until anodization time lasted for 35 minutes, as compared to the standard 25 minutes on a horizontal surface. The reduced flow rate permits gravity to force acid into all parts of the bagged surface area, and a uniformly anodized surface results. If the flow rate is too fast, lower corners of the bagged surface area will be bypassed as the acid "channels" through only the central region of the bagged surface. Figure 10 illustrates this phenomena. Similarly, a 16" X 16" panel required 45 minutes of anodization time to obtain a uniformly anodized surface. Figure 11 illustrates wedge test results for anodization of a vertical surface. The crack growth for the vertically anodized panels was slightly lower than that for the horizontal panel and both exhibited cohesive failure. Since the crack growth values for the vertical panels are only slightly less than those for the horizontal panels, no significant distinction should be made in terms of anodization effectiveness for each of these orientations.

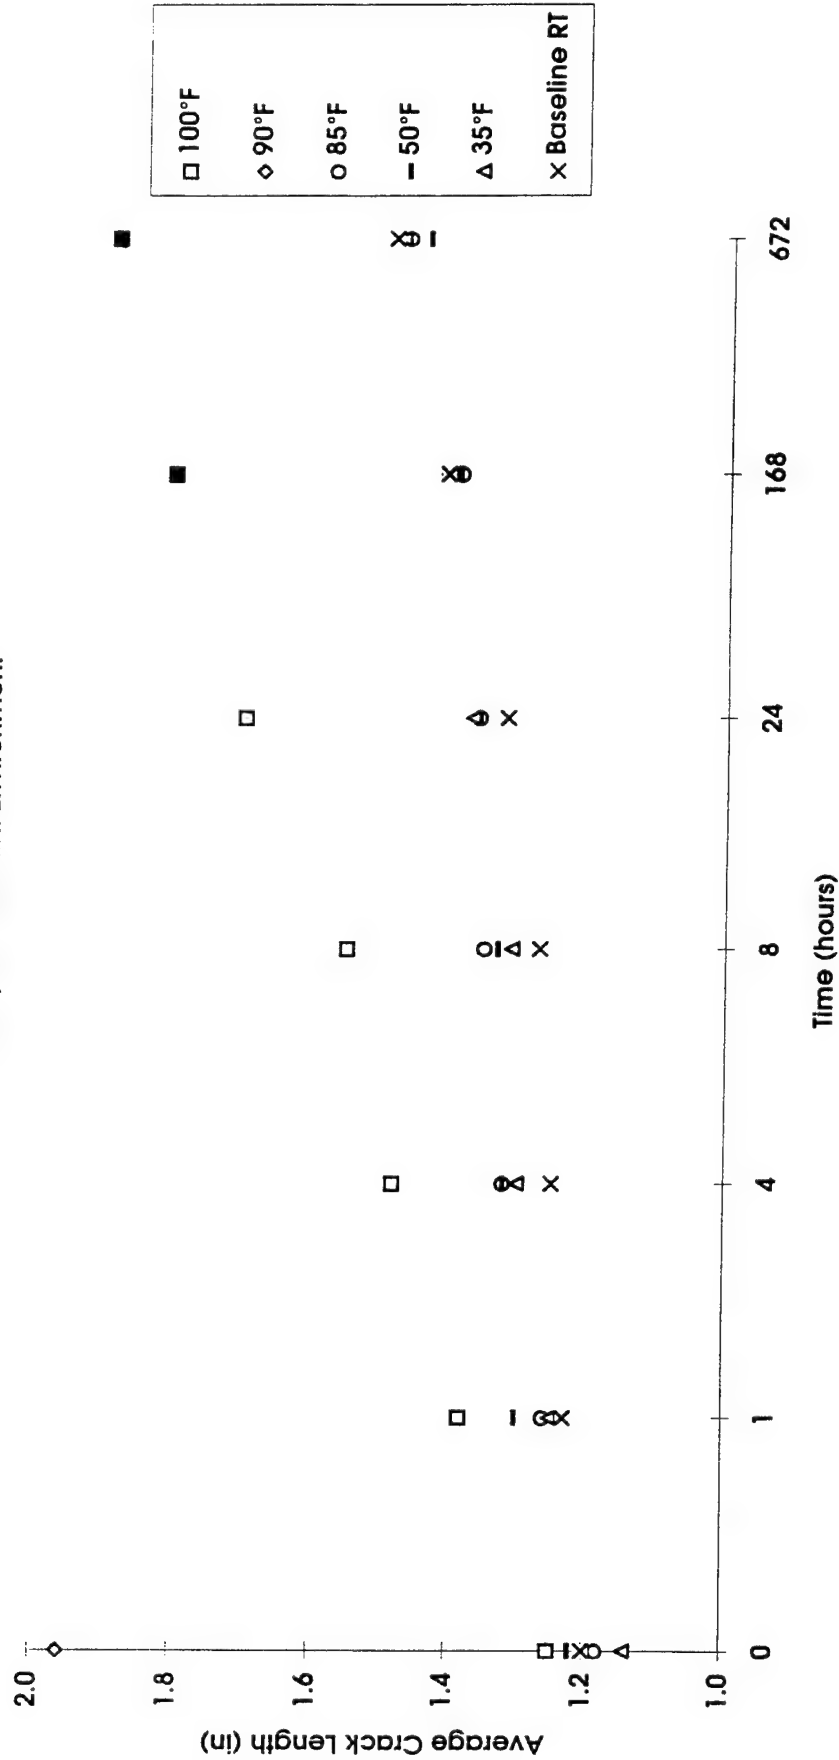
Figure 12. Effect of Processing Temperature on Crack Growth Behavior of PACS Prepared Surfaces

AI 2024-T3 Bare/BR 127/FM 73
140°F, 95-100% R.H. Environment

The effect of temperature on the surface being anodized was evaluated. Wedge test panels were anodized at temperatures ranging from 35°F to 100°F using the PACS unit. Figure 12 indicates that although the panel prepared at 50°F resulted in acceptable crack growth, the panel prepared at 100°F resulted in a significantly increased rate of crack growth. Multiple panels were tested at the various temperatures to confirm the upper temperature limits.

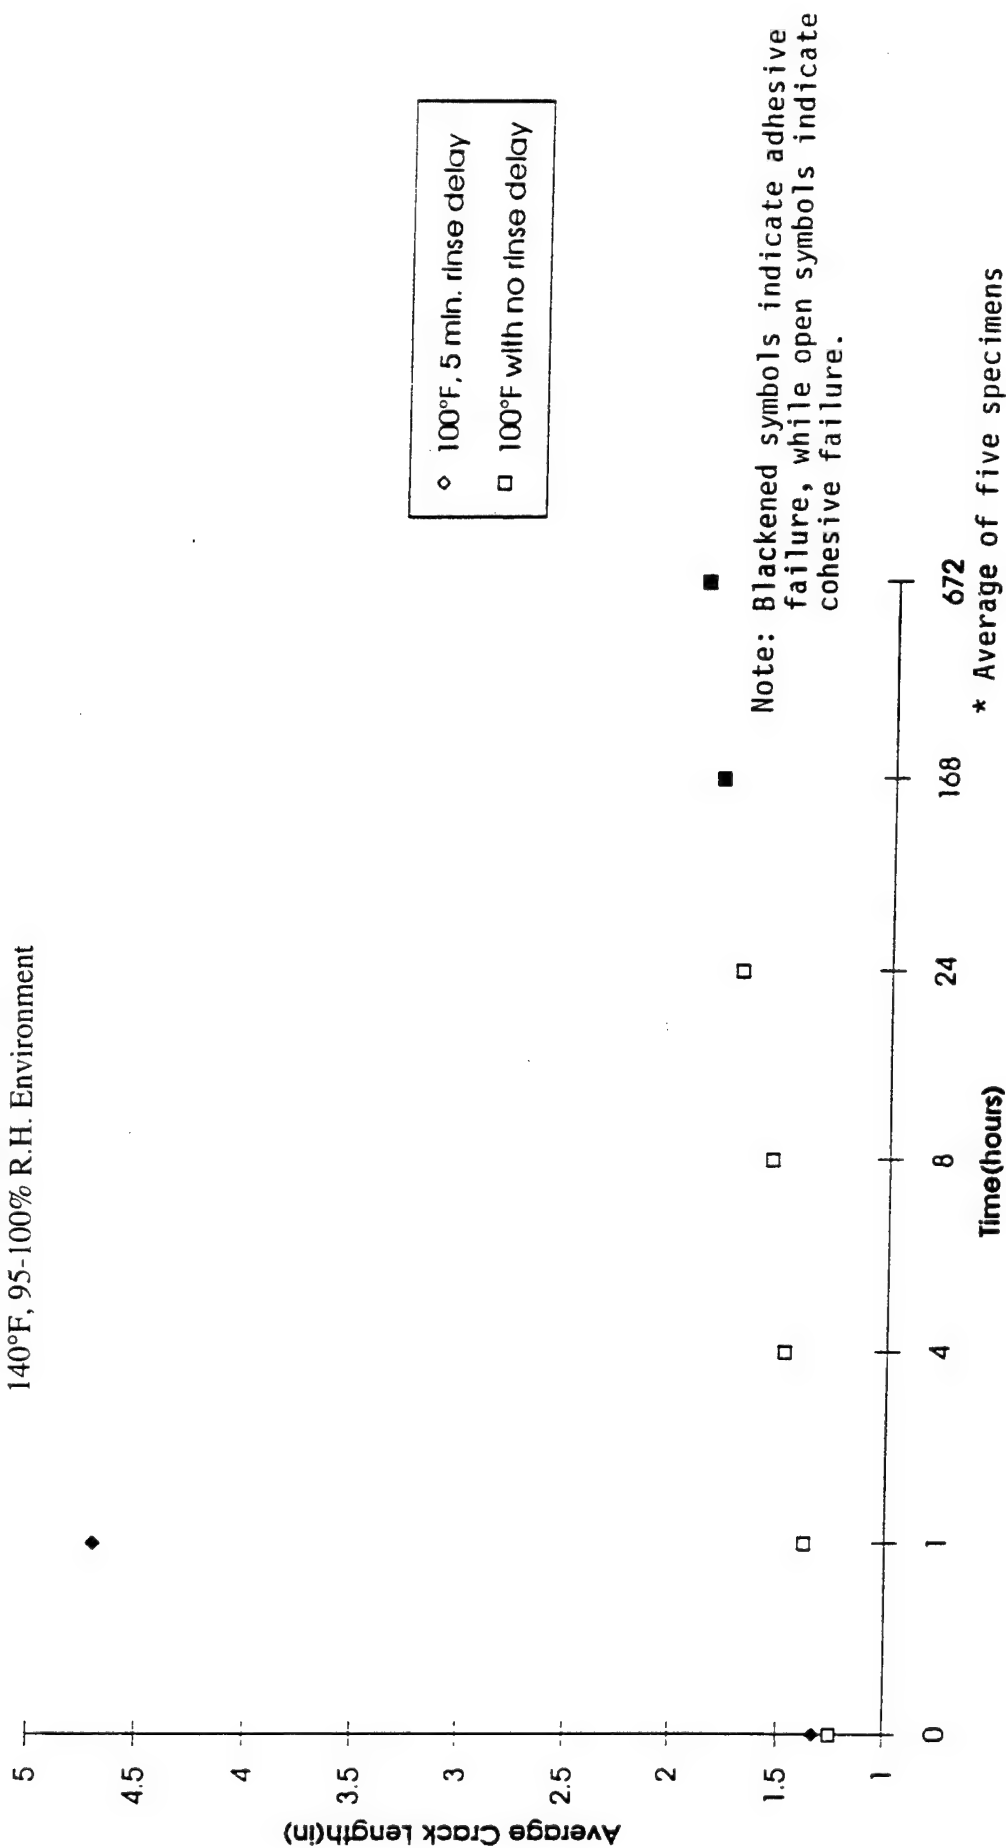
Figure 13. Effect of Five Minute Water Rinse Delay on Crack Growth Behavior of PACS Prepared Surfaces at 100°F

Al 2024-T3 Bare/BR 127/FM 73

140°F, 95-100% R.H. Environment

Figure 13 illustrates the effect of a 5 minute water rinse delay on crack growth behavior of a panel that was at 100°F while being PACS anodized. Adhesive failure occurred almost immediately for all wedge test specimens prepared at 100°F with a 5 minute rinse delay. Figure 14 illustrates the effect of a 5 minute water rinse delay on crack growth behavior of a panel that was anodized at room temperature (RT). Adhesive failure occurred almost immediately for all wedge test specimens prepared at RT with a 5 minute water rinse delay.

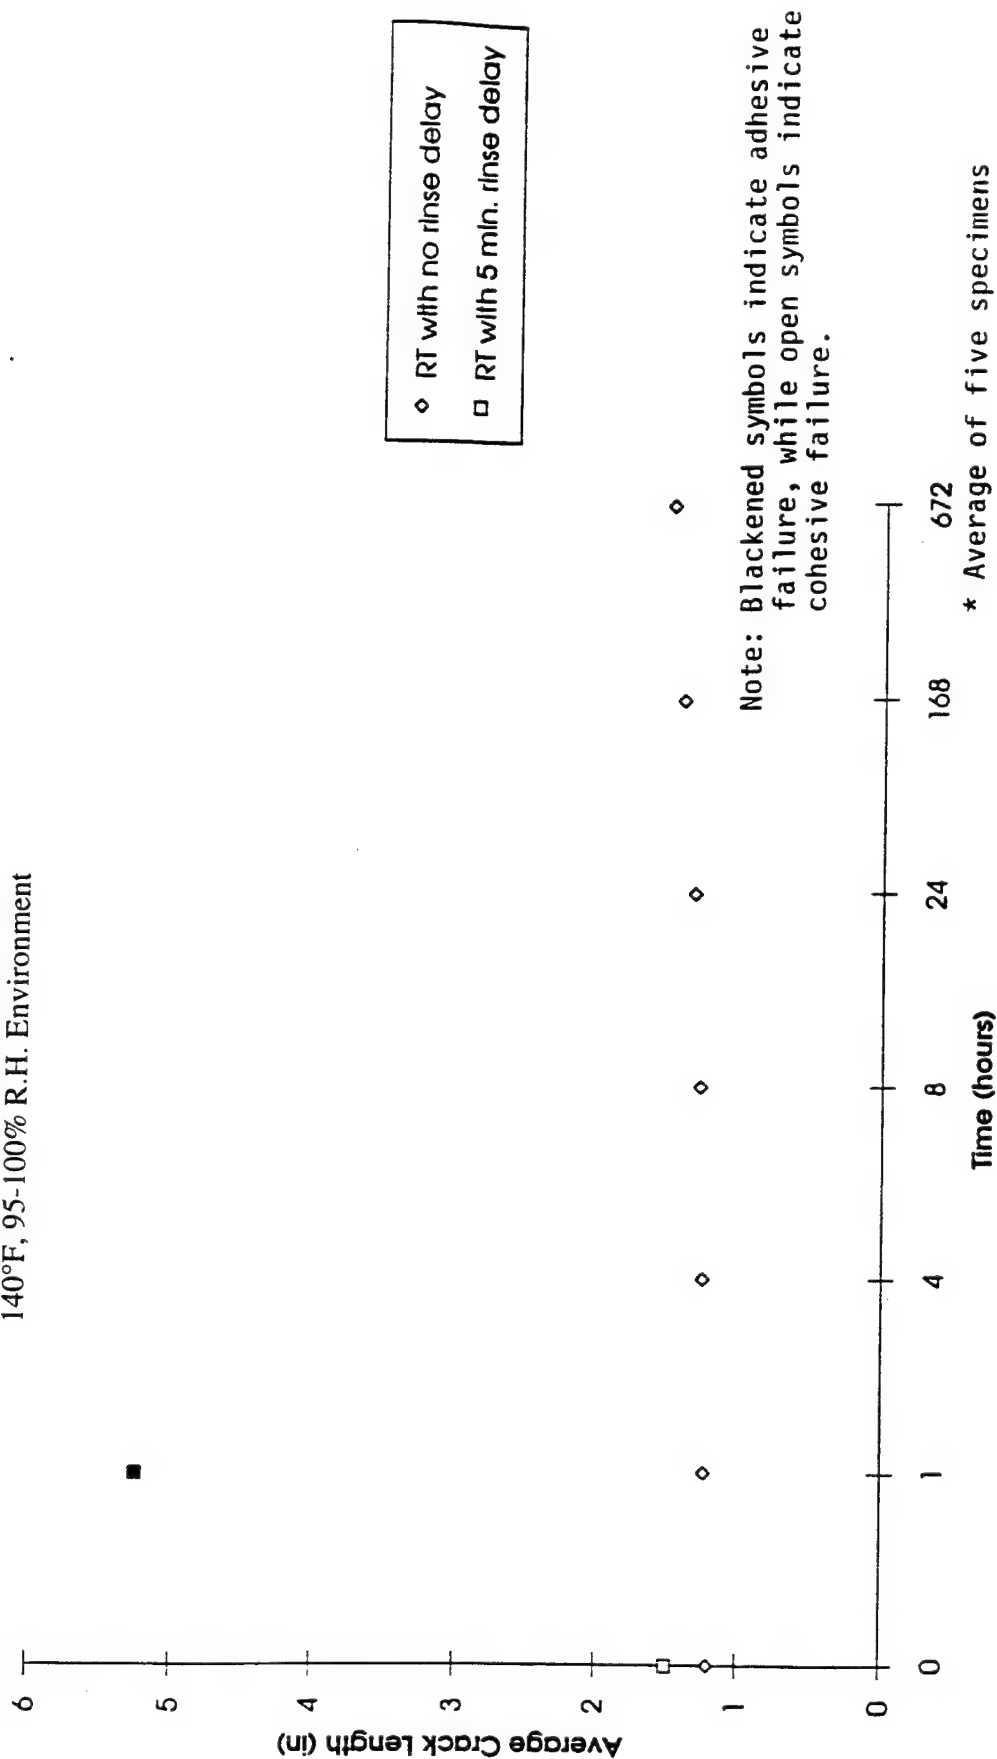
Figure 14. Effect of Five Minute Water Rinse Delay on Crack Growth Behavior of PACS Prepared Surfaces at RT

Al 2024-T3 Bare/BR 127/FM 73

140°F, 95-100% R.H. Environment

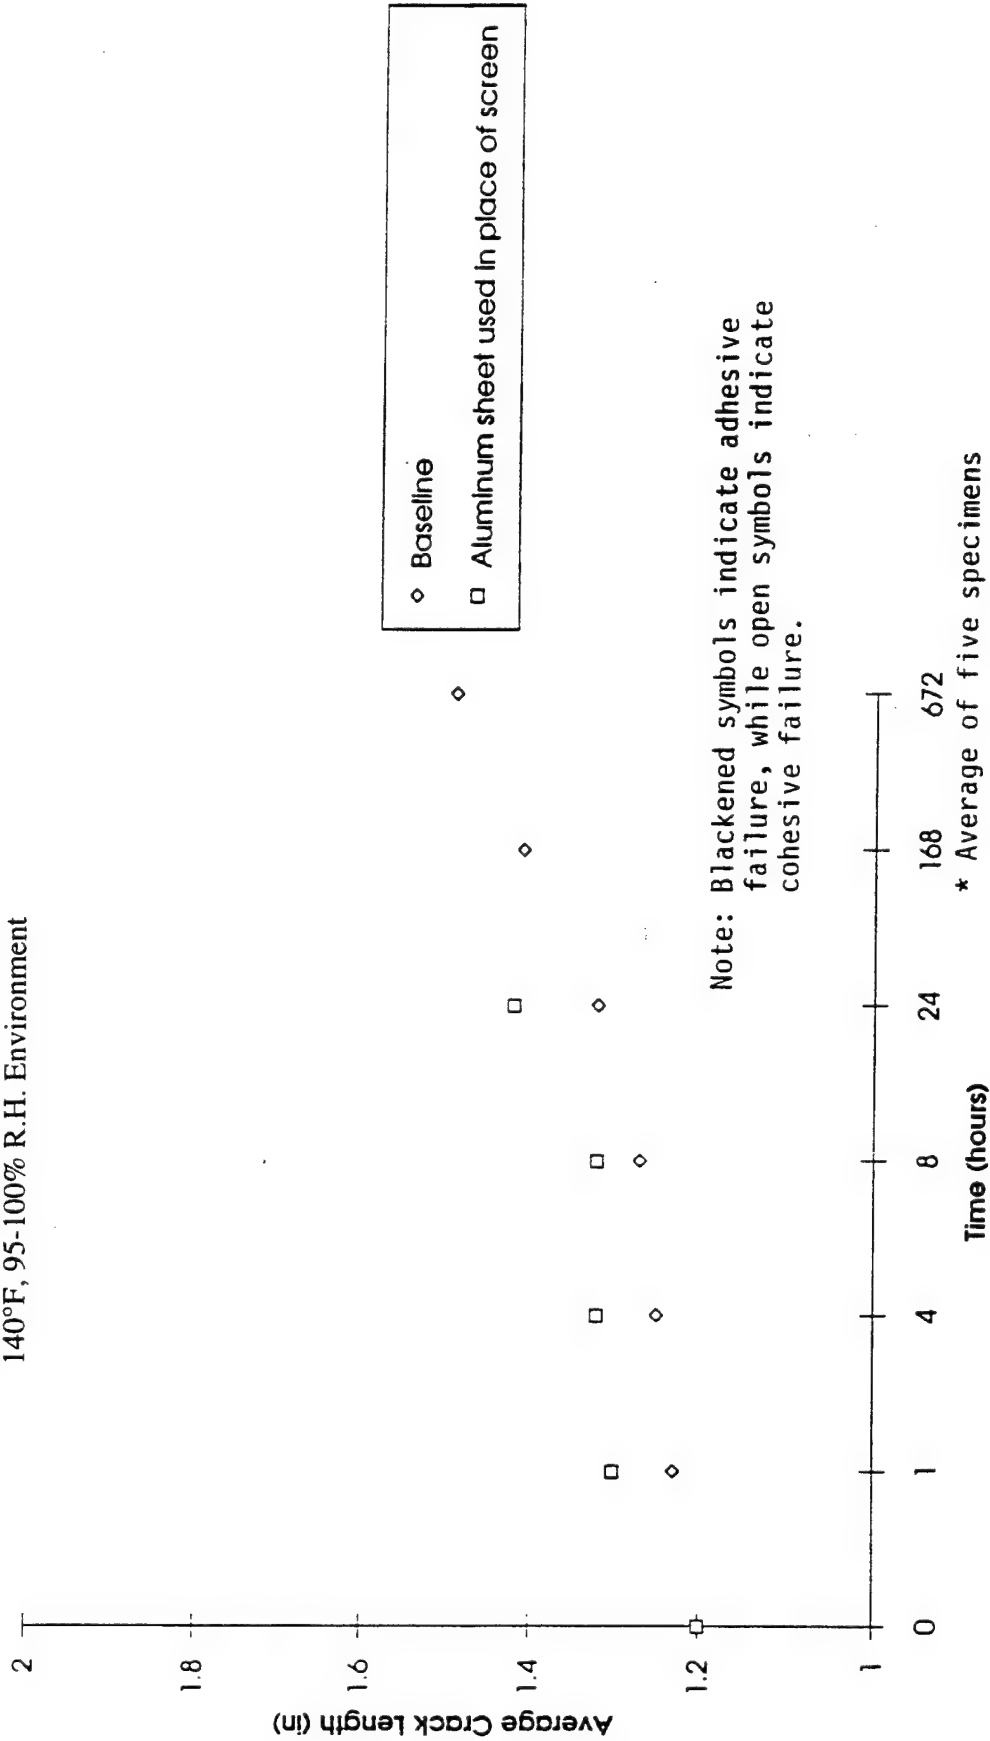
Figure 15. Effect of the Screen Type on Crack Growth Behavior of PACS Prepared Surfaces

Al 2024-T3 Bare/BR 127/FM 73
140°F, 95-100% R.H. Environment

Figure 15 illustrates the effect of screen type on crack growth behavior of PACS anodized surfaces. The screen supplied with the PACS kit was a stainless steel screen. Two alternative materials were utilized in place of the stainless steel screen: 0.063-inch aluminum sheet and aluminum foil. Although the aluminum foil was securely attached to the electrical lead, no current could be drawn and therefore, anodization was impossible. However, the aluminum sheet is a viable replacement for the stainless steel screen if needed.
